# ***Contractor's Guide to Efflorescence***

*By Doug Bannister*

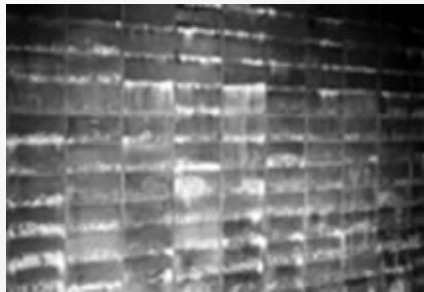
Efflorescence on concrete masonry.  
Photo courtesy of [Portland Cement Association](#).

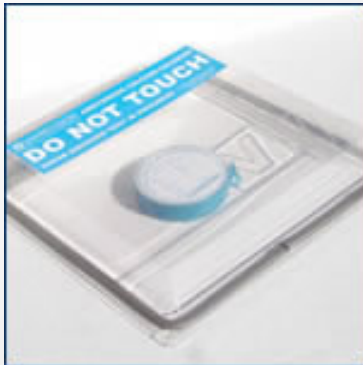
A Calcium Chloride Test is a good surface moisture test for determining the current vapor transmission rate of concrete. Photo Courtesy of Vaporprecision, Inc.

Even if some answers are provided it behooves the contractor to do some independent fact finding to determine the current vapor transmission rate (VTR). Probably the oldest test method is the Plastic Sheet Test (ASTM-D-4263) which is taping down a clear 18" X 18" sheet of poly and checking 16 hours later for condensation or for a darkened concrete surface. Both are indications of vapor transmission. Another surface moisture test is The Calcium Chloride Test which quantifies the rate of vapor transmission. This is a covered dish that is weighed before and after a twenty four hour period. Both are cost effective measures in determining whether vapor is active.

A note of caution when using these testing methods...the plastic sheet and chloride tests will track moisture movement near the top only. When the atmospheric conditions are similar to the slab conditions the tests might not indicate significant vapor transmission because movement happens when the ambient conditions differ from the slab conditions. Moisture migrates and moves toward cool temperatures. Vapor emissions migrate and move toward heat. Imagine the consequences of the following unpleasant, but very real scenario... the project is completed, the contractor has been paid, the delighted owner takes possession and turns on the HVAC causing vapor in the slab to move towards the warmth or the lower humidity of the conditioned space bringing the whitish minerals with it. If the sealer is acrylic the vapor will pass through leaving the efflorescence. If urethanes or epoxies are on the floor, hydrostatic pressure may build and possibly cause delamination. Efflorescence can occur months or even years after the contractor has left the job due to circumstances similar to those just described or from seasonal ground water seeping under the slab. Testing the surface may not be enough to guarantee an efflorescence free project for years to come. It is important to determine the source and the rate of vapor transmission before prescribing a remedy.

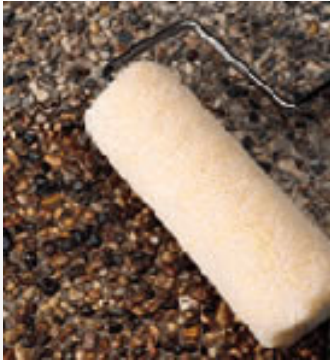
Some contractors are following the application of acid stains with silicate type non-film forming sealers generically described as chemical hardeners, densifiers and soluble chloride reducers within a few days of concrete placement.

Secondly, some contractors are following the application of acid stains with silicate type non film forming sealers generically described as chemical hardeners, densifiers and soluble chloride reducers within a few days of concrete placement. Efflorescence is reduced as the silicate causes the matrix to become denser as we described earlier. The contractor has the option of adding conventional membrane forming sealers if subsequent VTR tests indicate acceptable levels.
